ADVANCED CRYOGENIC ROCKET ENGINE PROGRAM
AEROSPIKE NOZZLE CONCEPT -- MATERIALS AND PROCESSES
RESEARCH AND DEVELOPMENT REPORT

Rocketdyne, A Division of
North American Rockwell Corporation
6633 Canoga Avenue
Canoga Park, California

Technical Report AFRPL-TR-67-278

November 1967

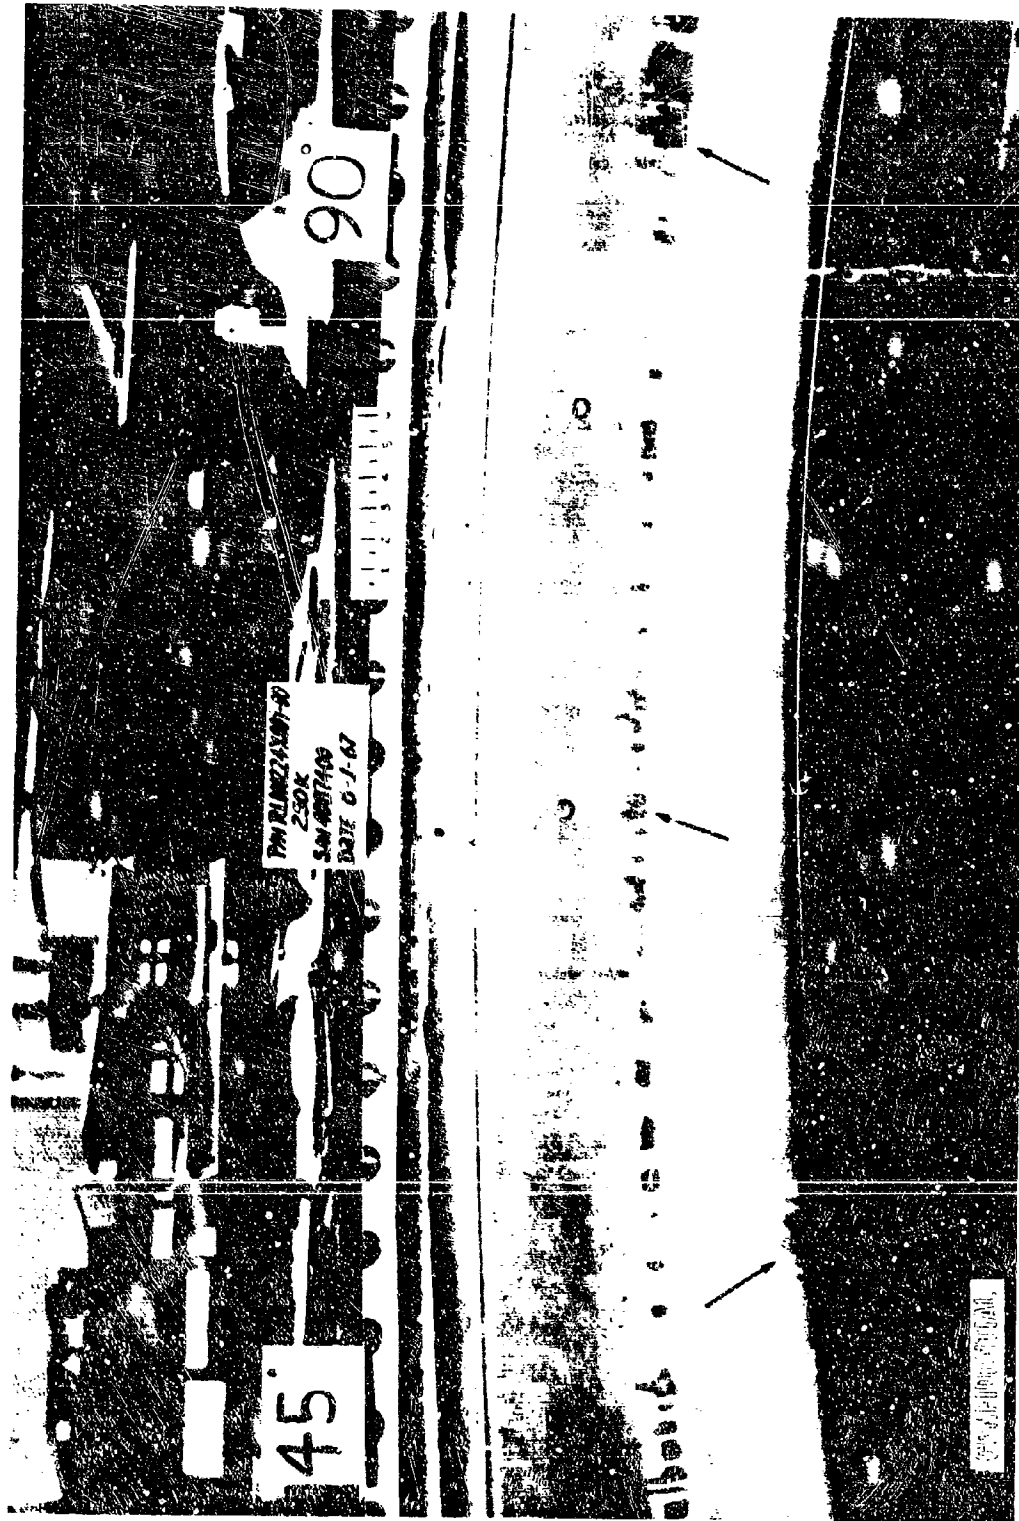
Figure 31. Thermographic Inspection Results Showing Areas of Disbands Indicated by Dark Areas (Arrows) on Outer Combustor Unit No. 2

(U) An example of the test results can be seen in Fig. 31 which shows the changes that occur when testing an actual piece of hardware.

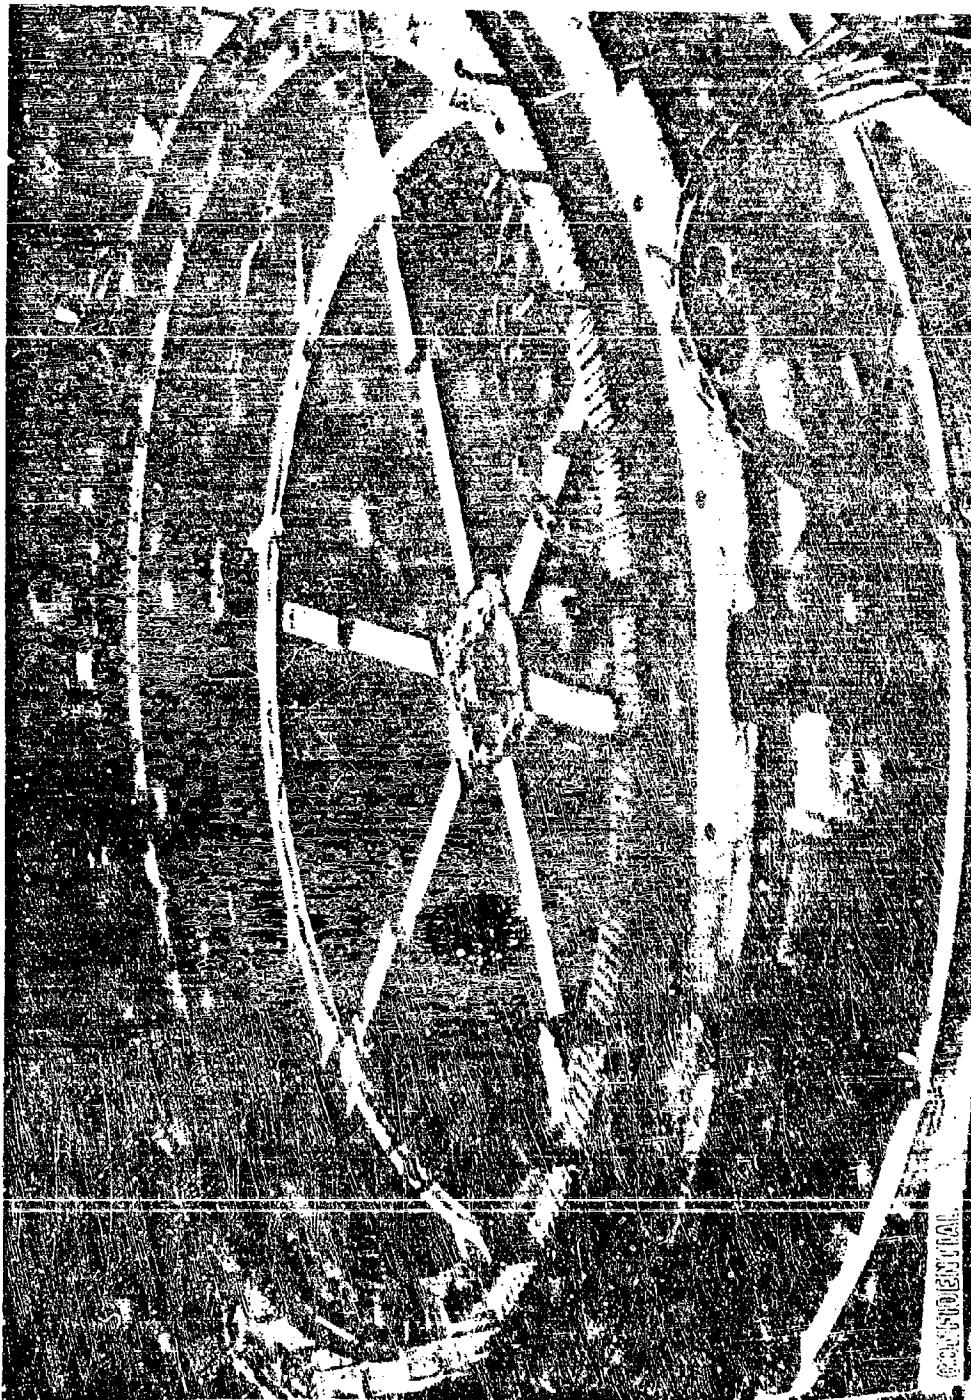
A - No. 8 thermocouple attached
B - No. 9 thermocouple attached
C - Position of thermocouples for retort outlet

Figure 38. Partial Thermocouple Attachment

(U) Figure 38 shows an injector assembly with some of the thermocouples attached. Figure 39 shows the injector retort on the furnace hearth with the purge gas lines, thermocouple duct, and vacuum duct attached.
